**Safety Improvements at Route 1, Central and Glenn Streets
Rowley, Massachusetts**

Project File No. 609392

Alternatives Analysis Memorandum

**Massachusetts Department of Transportation
Highway Division**

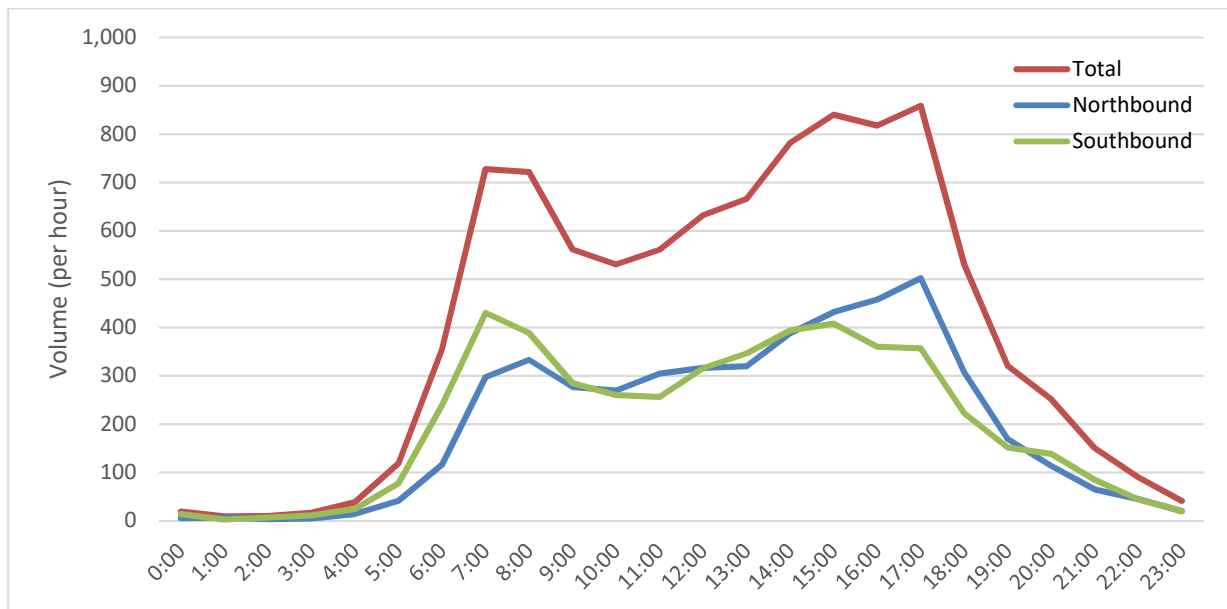
Figure 2 - Average Daily Traffic Variations - Route 1

Table 1 summarizes the 2020 base year daily and peak-hour traffic volumes at the locations where ATR counts were taken. **Figure 2** through **Figure 4** shows the weekday hourly traffic counts throughout the day. **Figure 5** represents the 2020 weekday morning (7:30-8:30 AM) and evening (5:00-6:00 PM) peak hour turning movement volumes at the project area intersection.

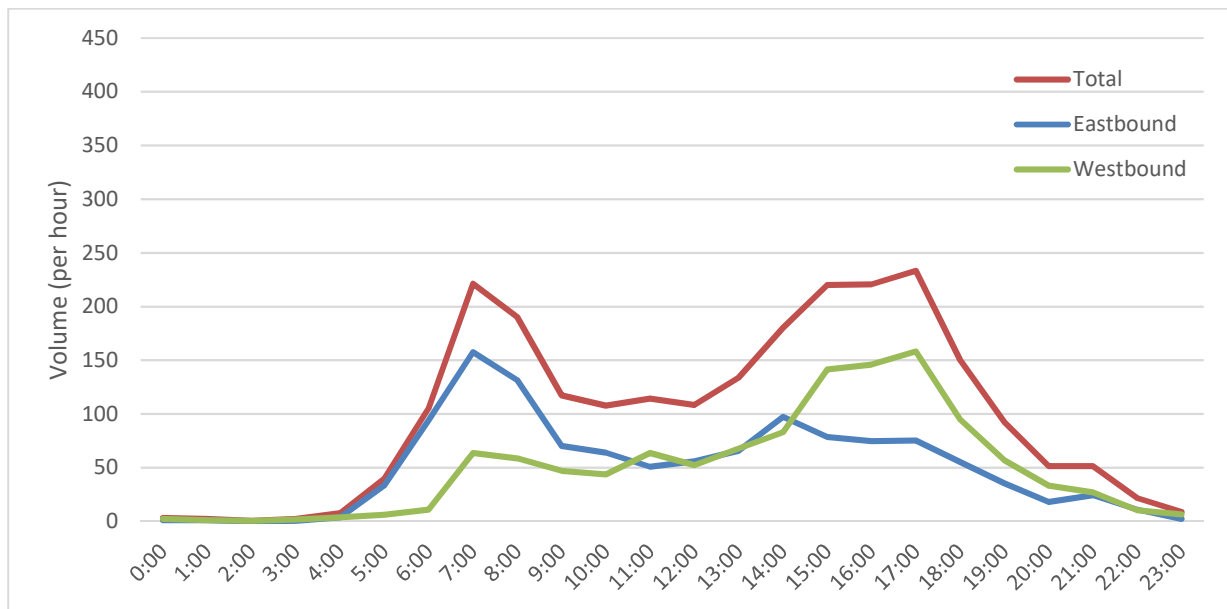
Figure 3 - Average Daily Traffic Variations - Glen Street

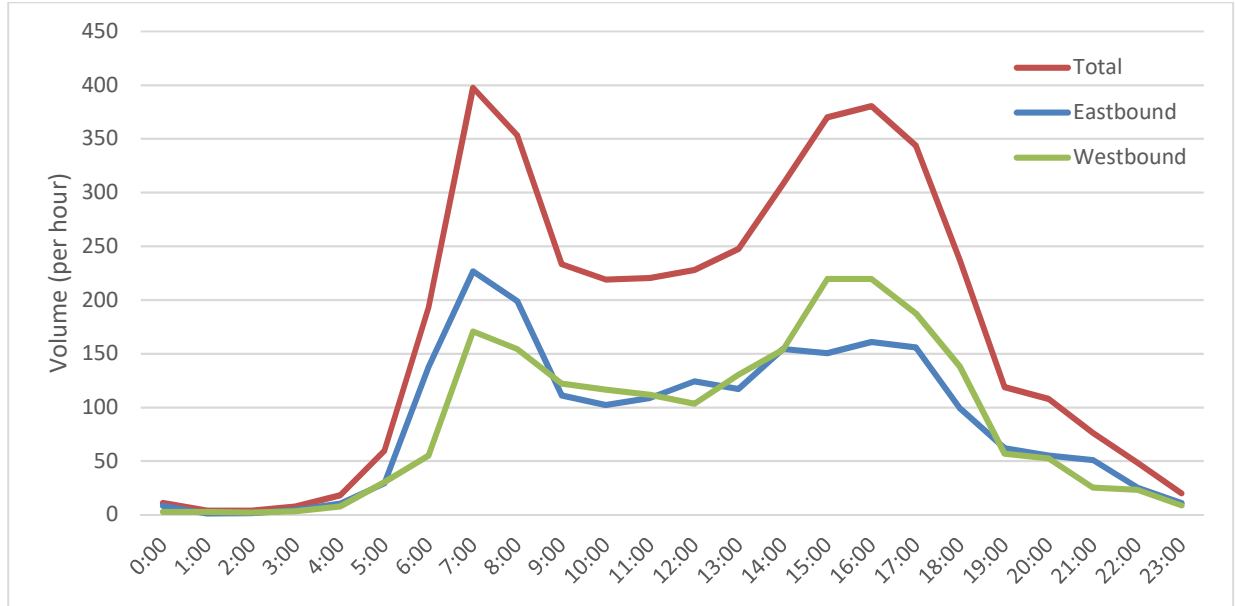
Figure 4 - Average Daily Traffic Variations - Central Street

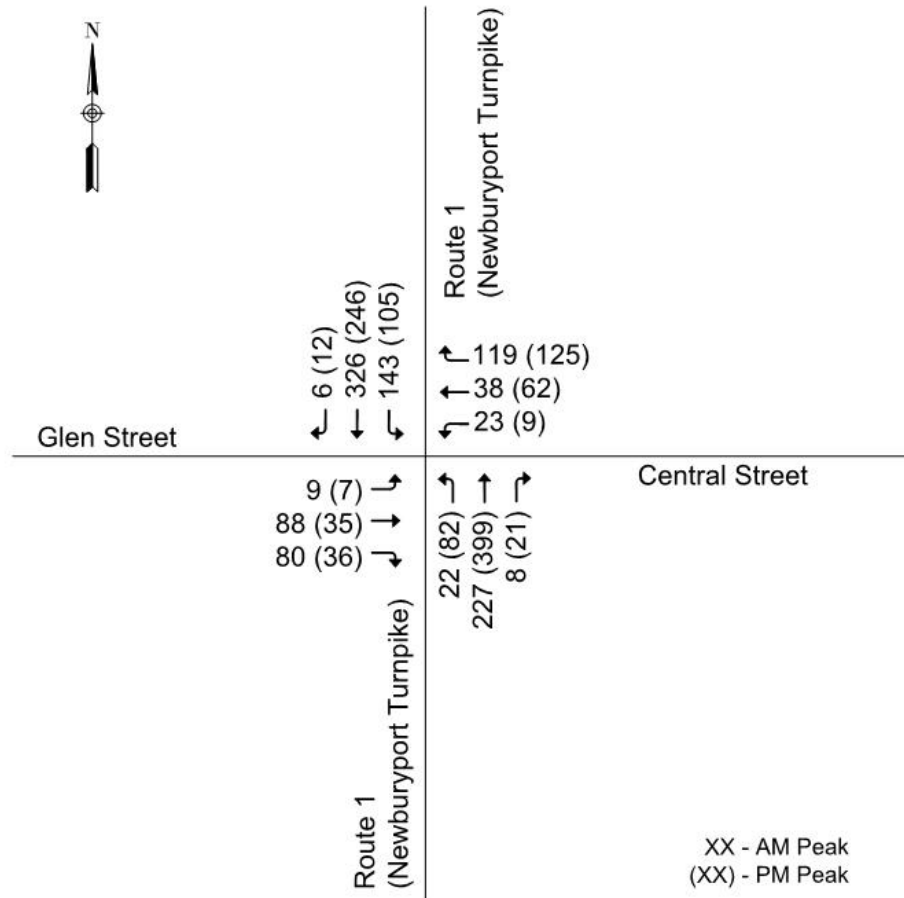
Figure 5 - Existing (2020) Peak Hour Turning Movement Volumes

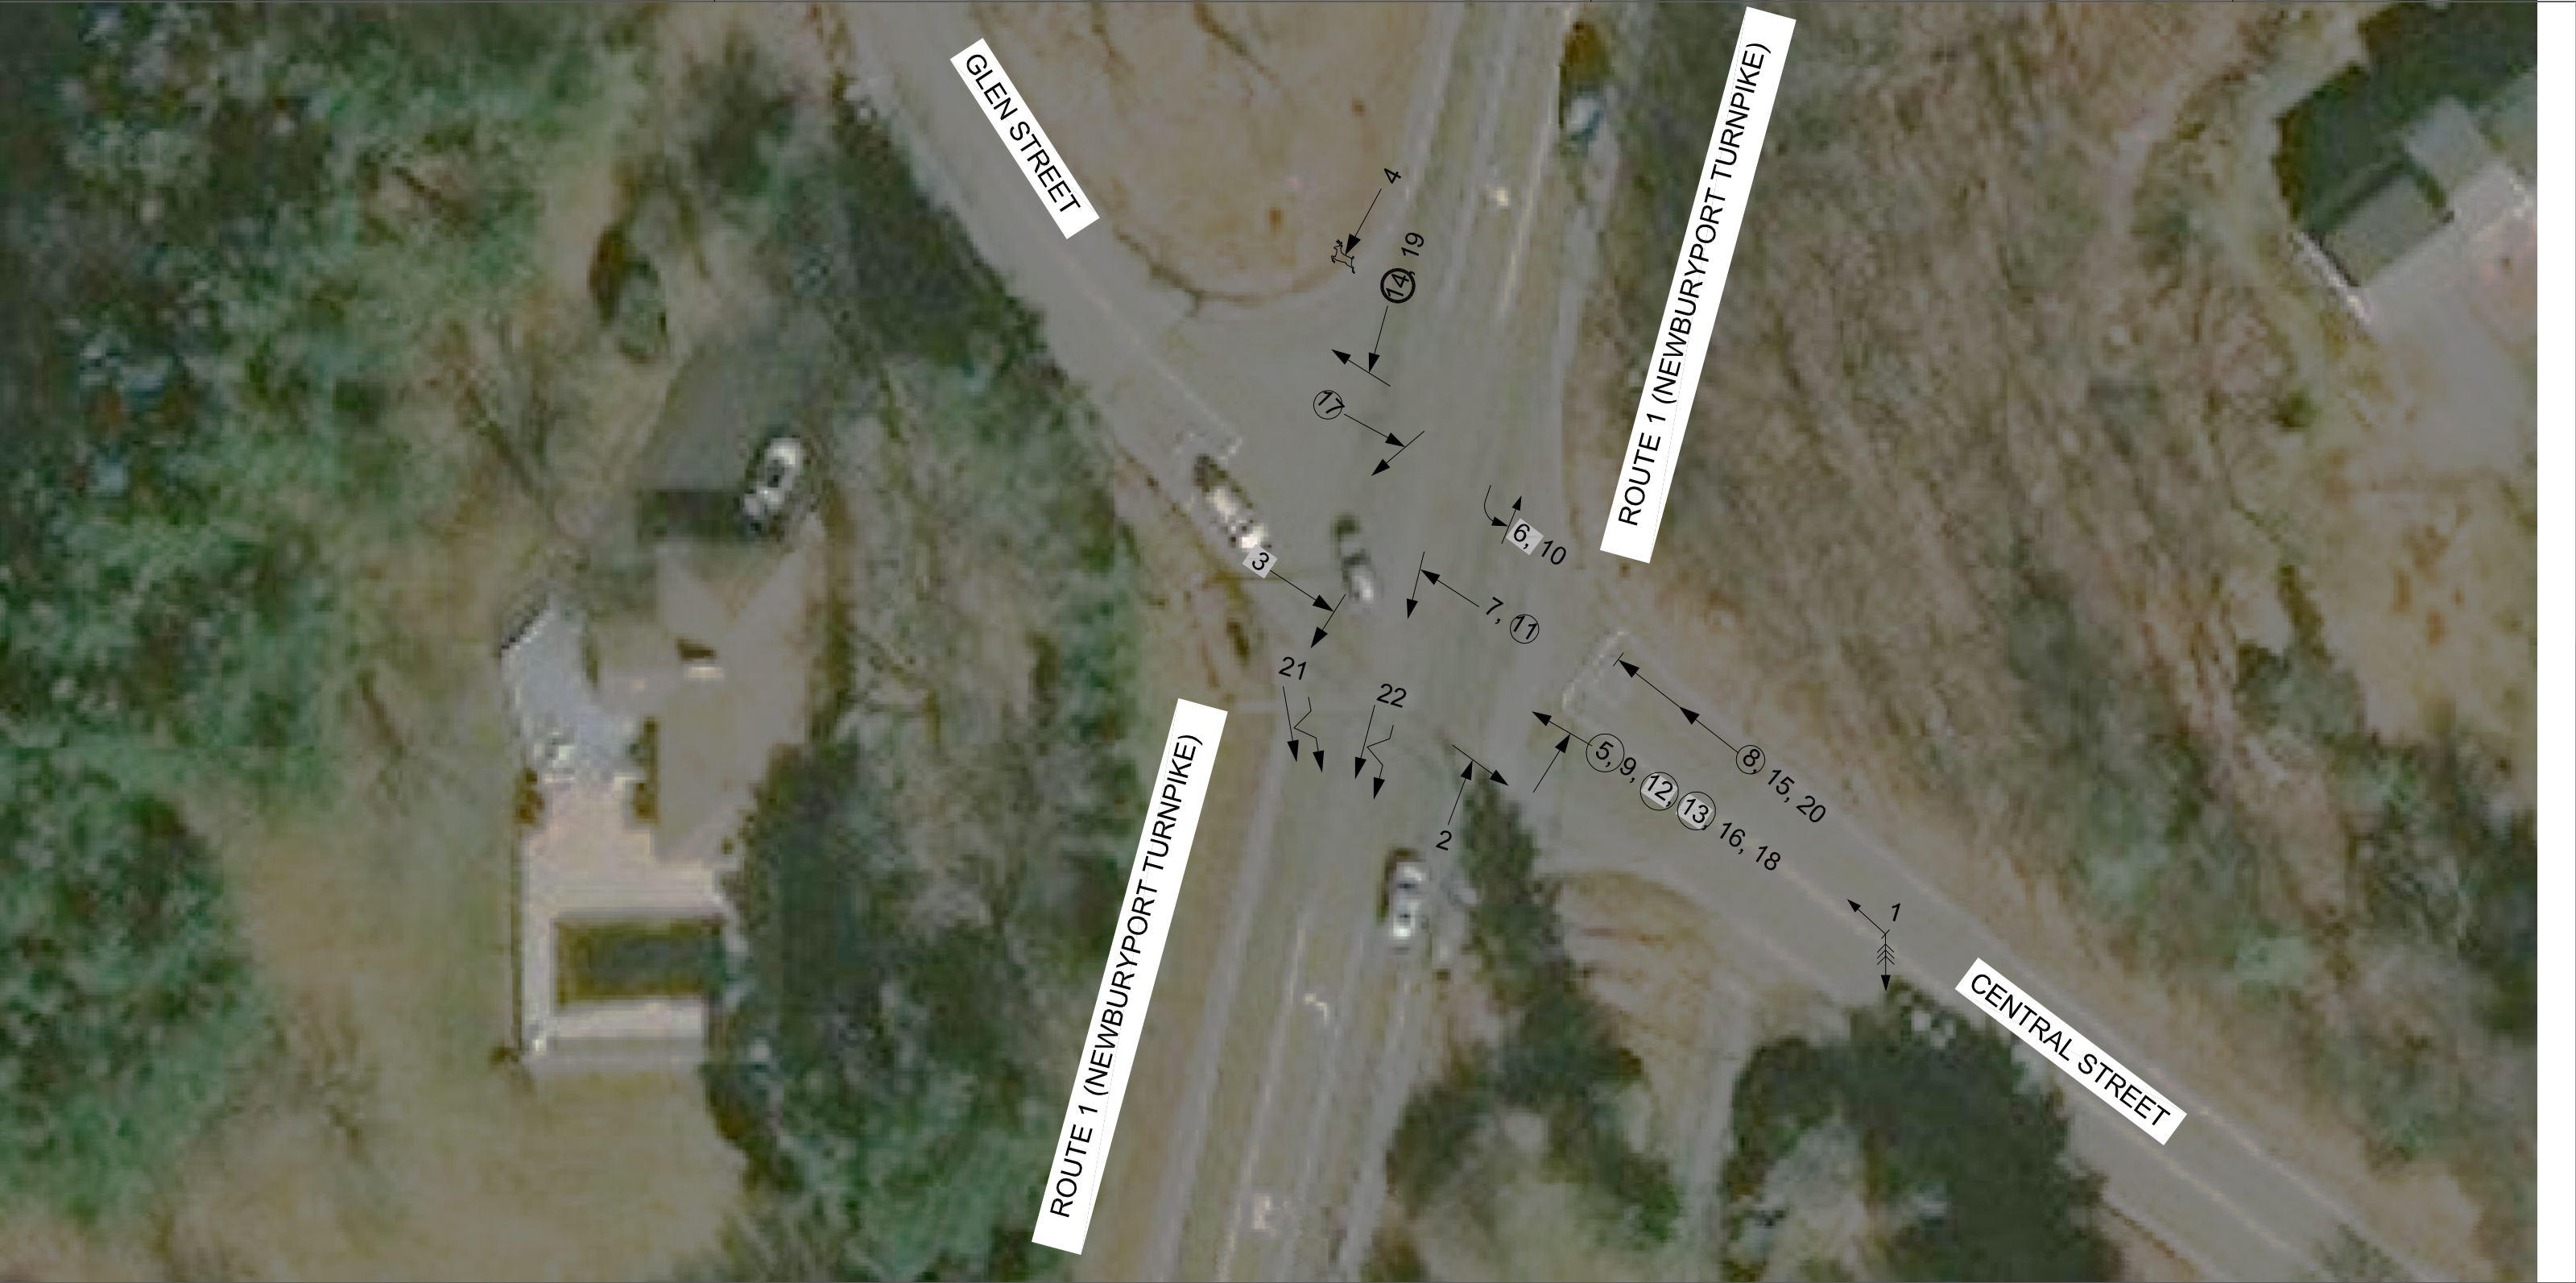
Crash Data Summary Table
Route 1 (Newburyport Turnpike) at Glen Street and Central Street, Rowley MA
January 2014 - December 2019

The summarized crash data for the project area can be seen in **Table 4**. The crash diagrams can be found in Appendix B.

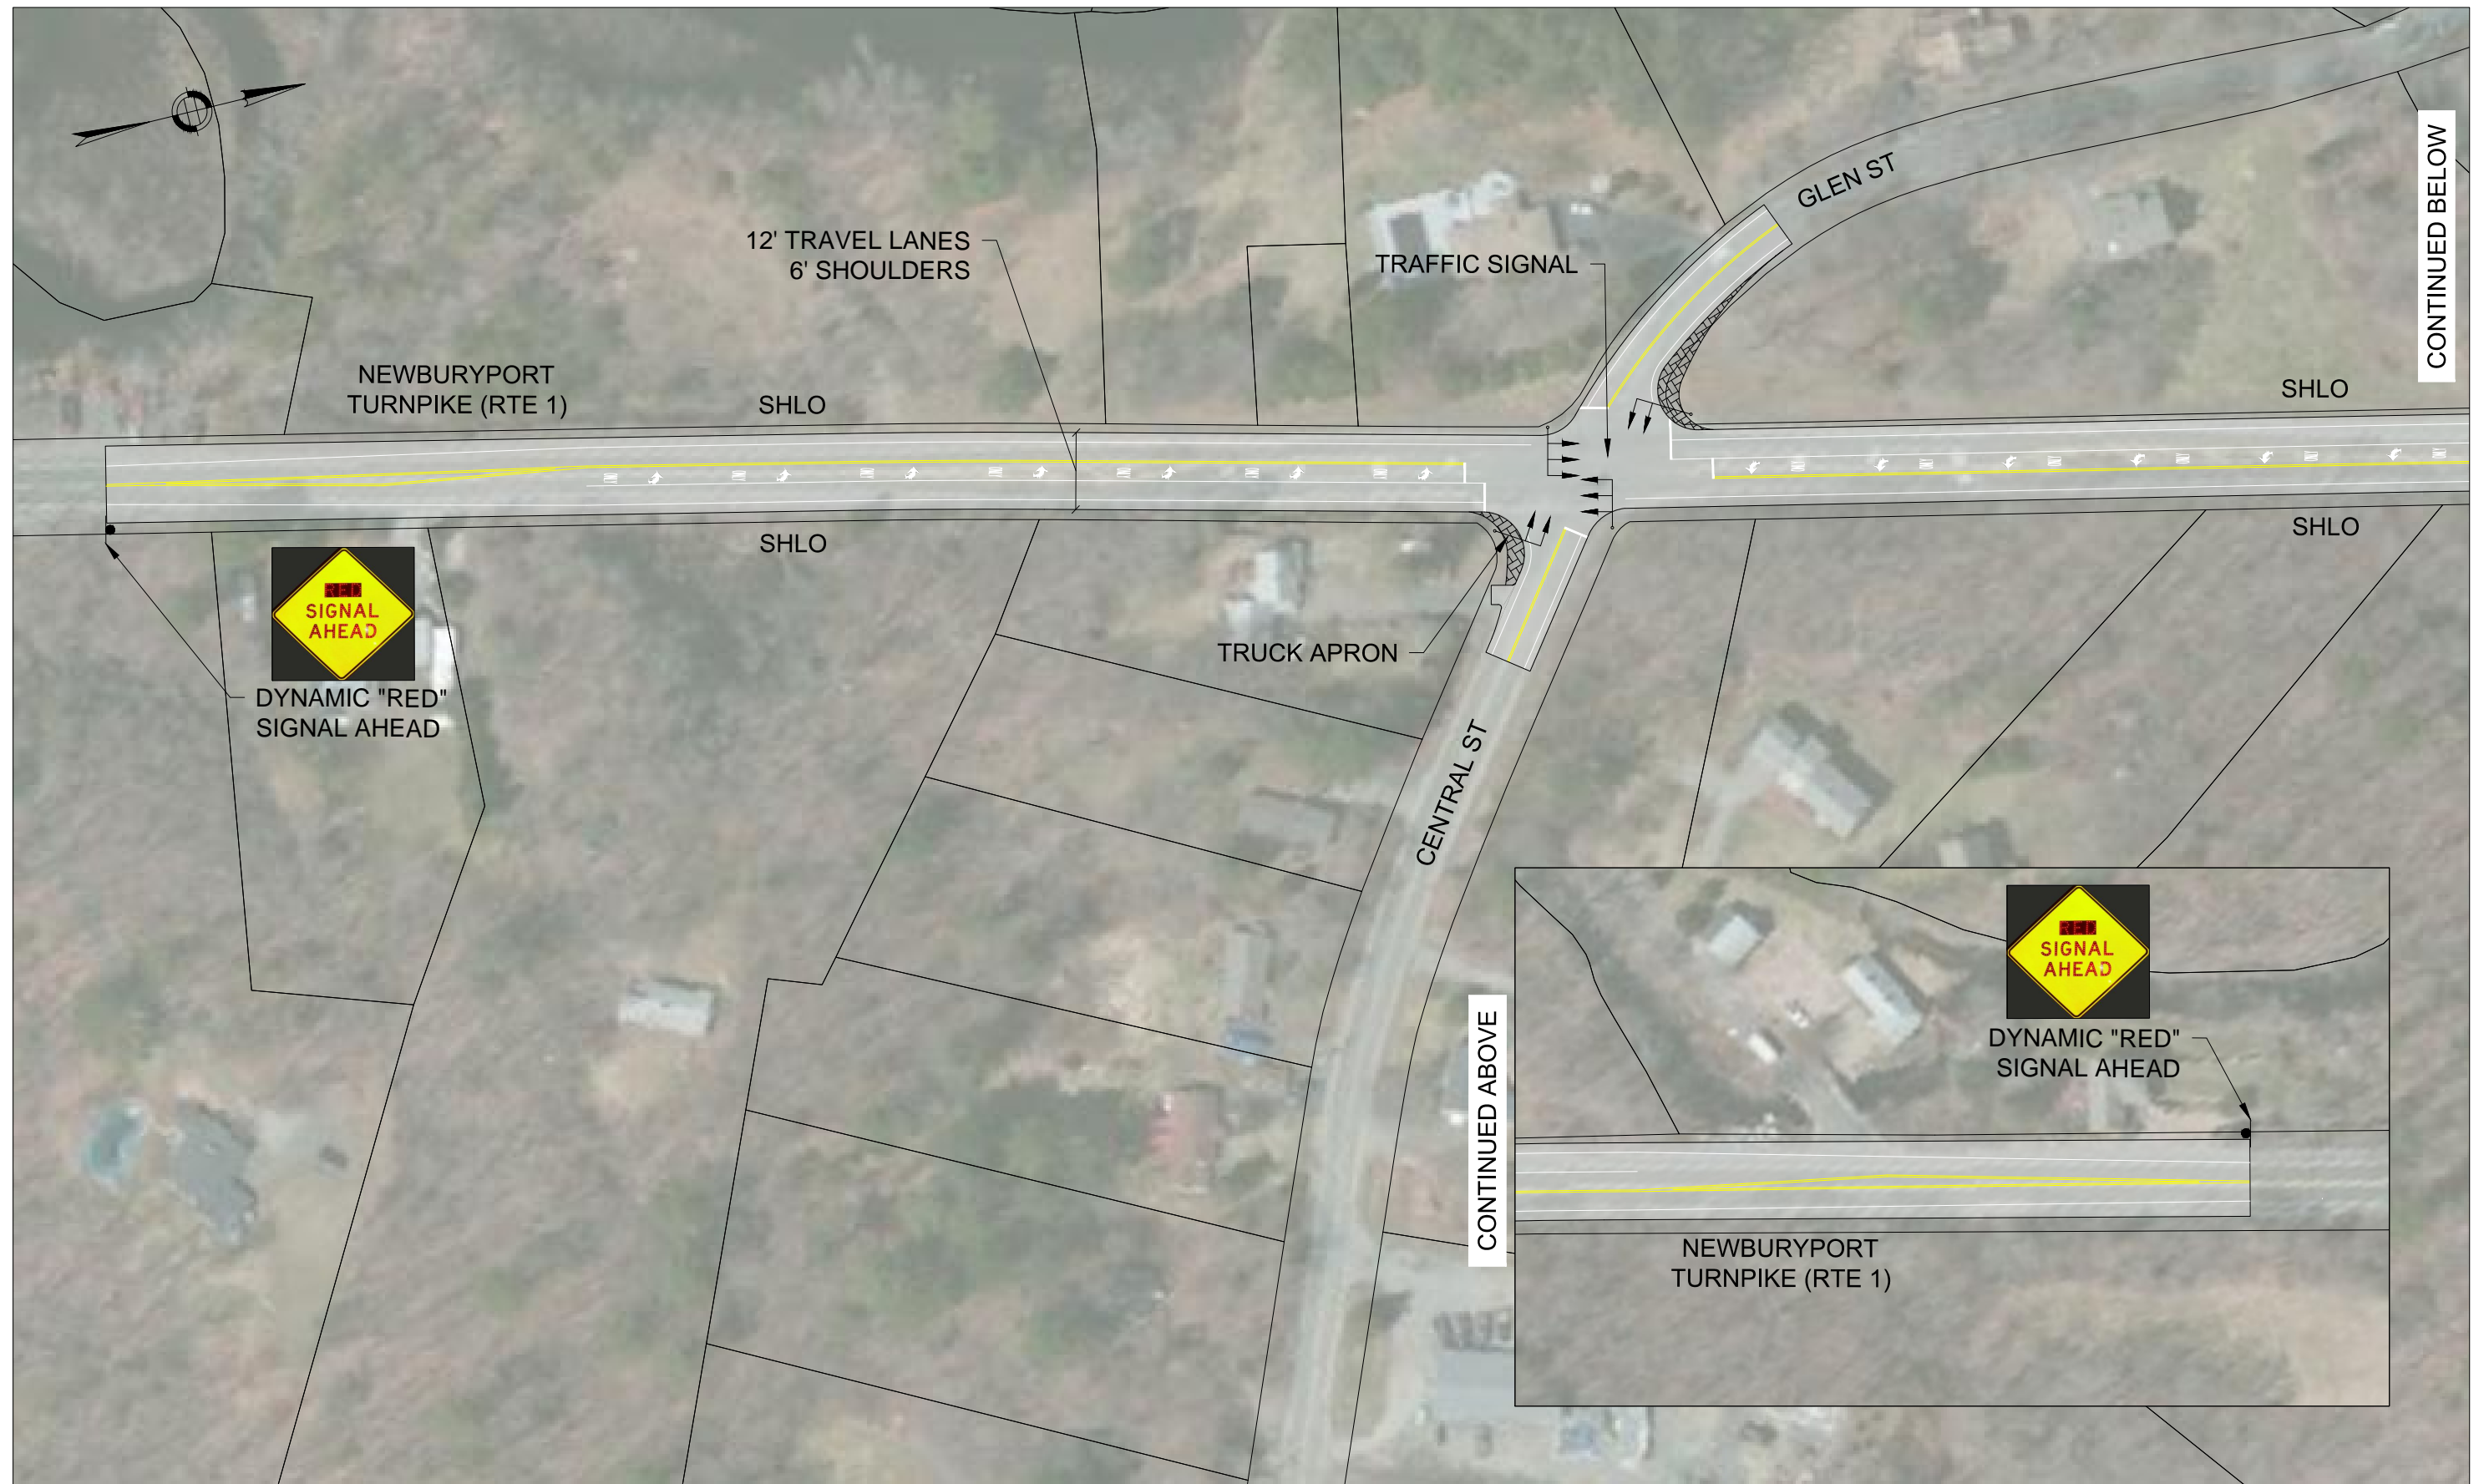
ALTERNATIVE 1 - SIGNALIZED INTERSECTION

It should be noted that full signal control will eliminate the need to judge gaps in Route 1 traffic for vehicles approaching from the side streets, a difficult task with existing sight distance constraints. Additional profile adjustments and sight distance improvements could be incorporated into the design once a more detailed survey is received and evaluated.

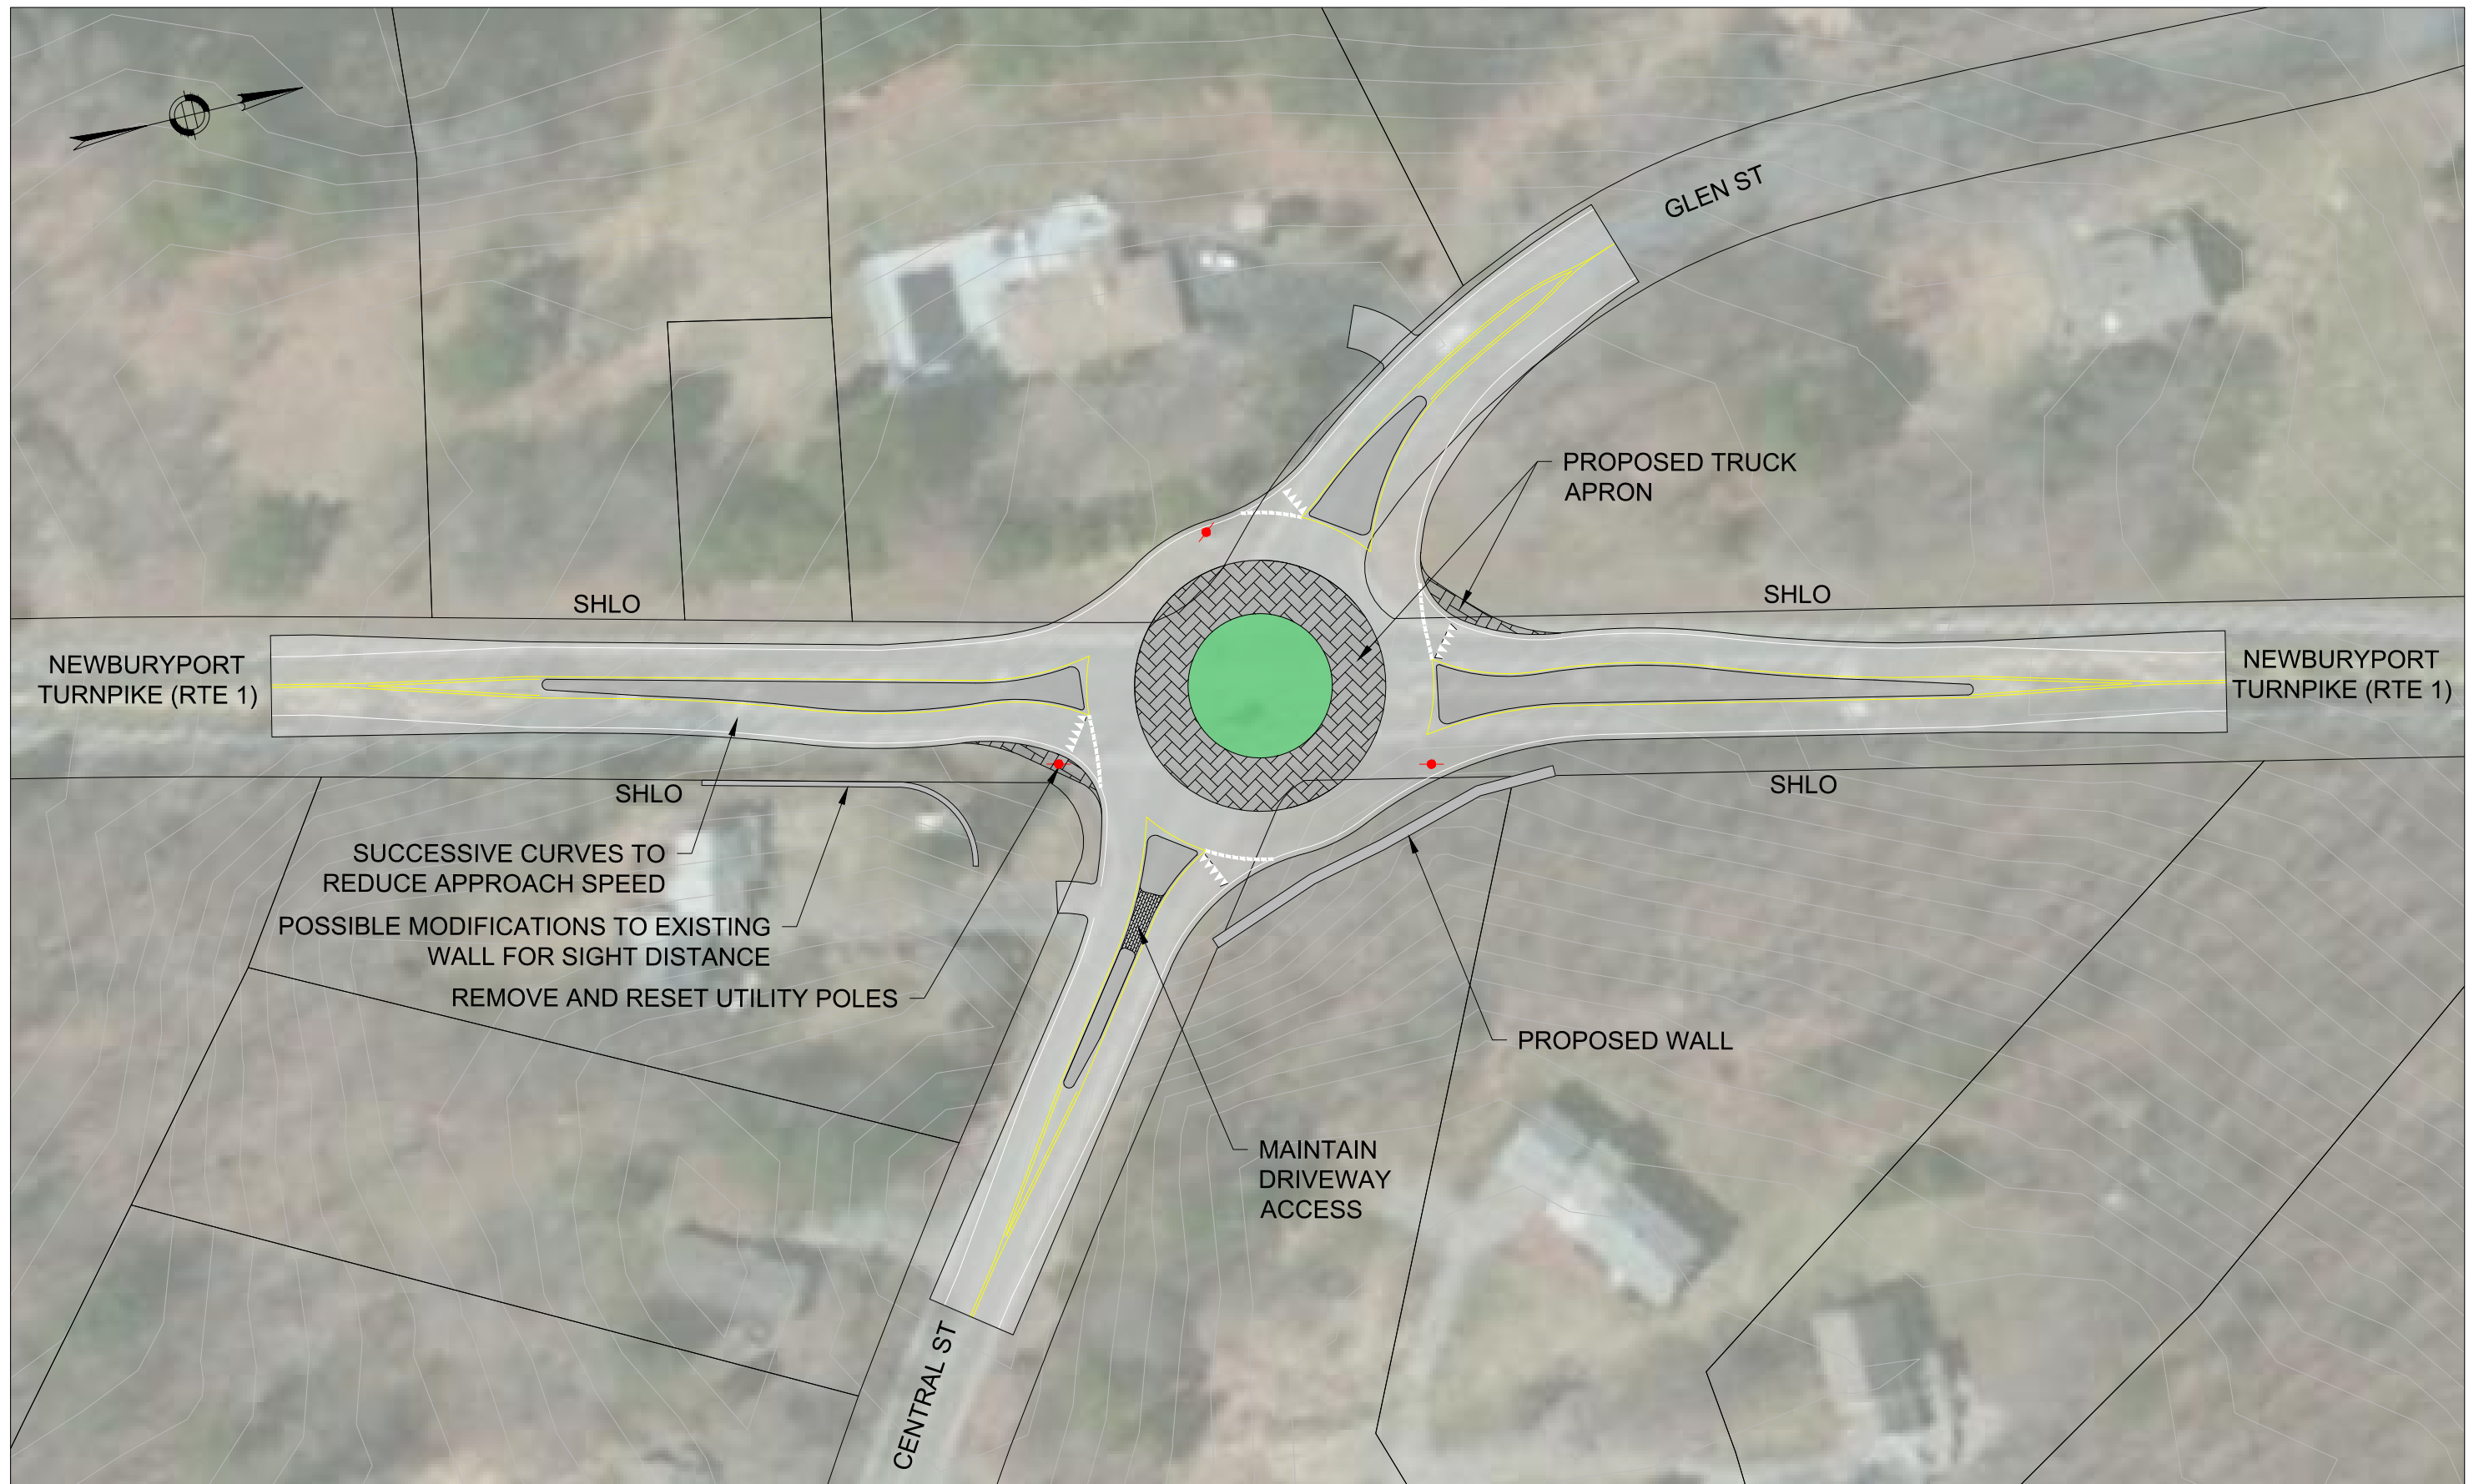
ALTERNATIVE 2 - SINGLE-LANE ROUNDABOUT

It should be noted the roundabout will eliminate most sight distance issues. Additional profile adjustments and sight distance improvements could be incorporated into the design once a more detailed survey is received and evaluated.
