REQUEST FOR CERTIFICATE OF COMPLIANCE CHECKLIST Under the Wetlands Protection Act and Rowley's Wetlands Bylaw

Re: DEP File No. 063-0659
101 Main Street
Owner/Applicant: Gerald Fandetti, Firehouse Inn, LLC

AS-BUILT PLAN OF LAND
IN
ROWLEY, MASSACHUSETTS
101 MAIN STREET
(ASSESSOR'S MAP 25, LOT 92)
PREPARED FOR:
FIREHOUSE INN, LLC

**RE: Final Monitoring Report:
101 Main Street | Rowley, MA 01969**

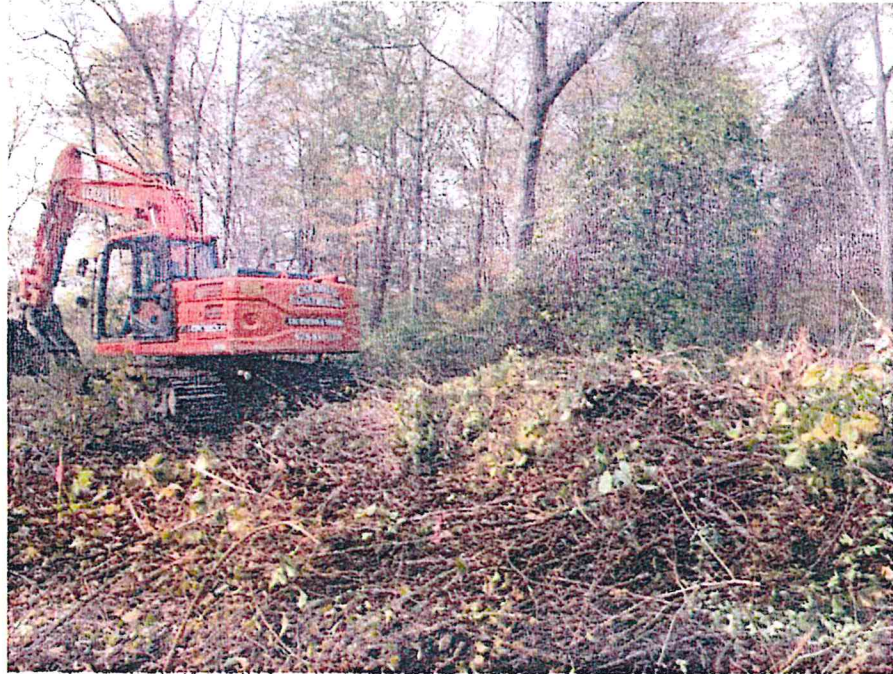
Photo 1: November, 2017

Invasive species were removed from the restoration area using whole plant removal techniques in November of 2017 to prepare for native plant installation.

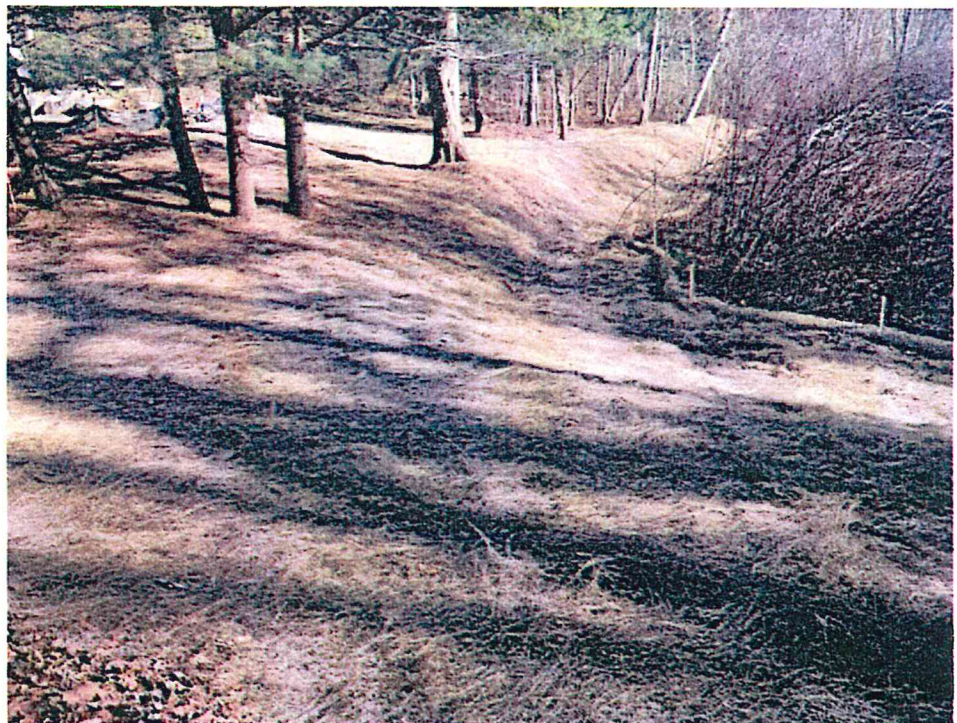
Photo 2: November, 2017

Exposed soils were seeded and hay mulched for stabilization over the winter.

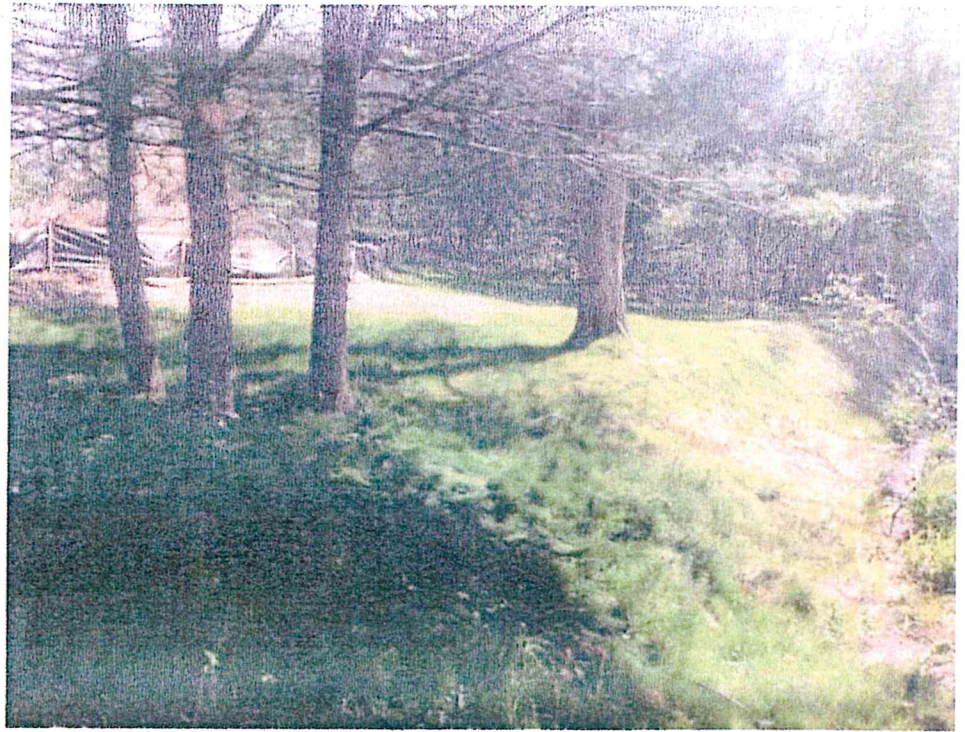
Photo 3: May, 2018

Throughout the 2018 growing season, the restoration area was monitored and any invasive species seedlings that appeared were removed by hand. The seed germinated and created a dense groundcover. Any areas where the seed did not germinate was re-seeded and hay mulched.

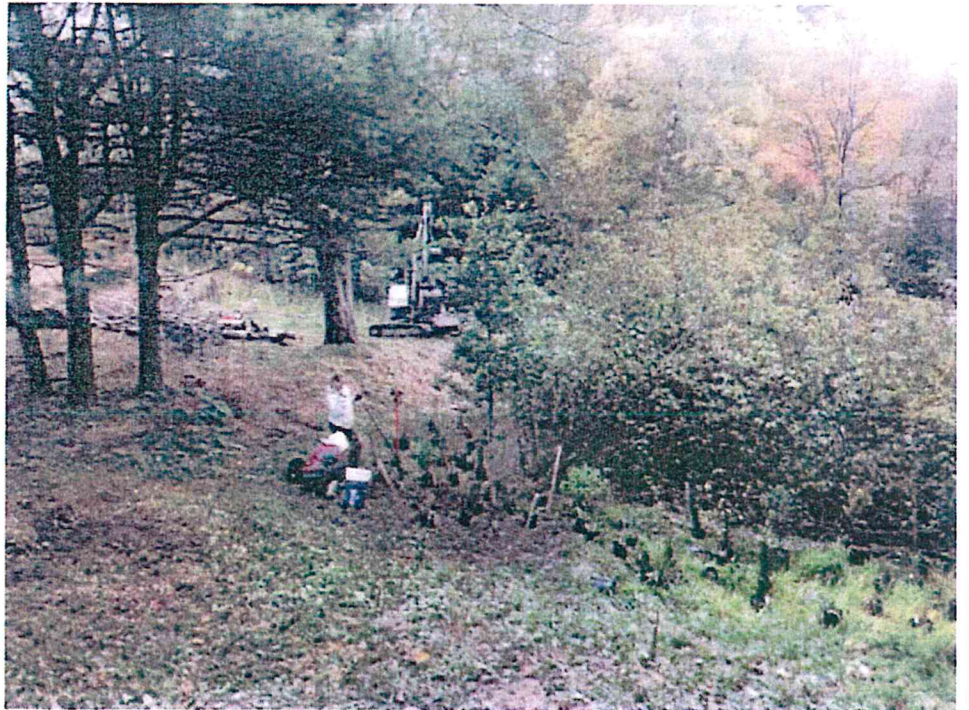
Photo 4: October, 2018

Plantings were laid out and installed according to the approved plan in October of 2018.

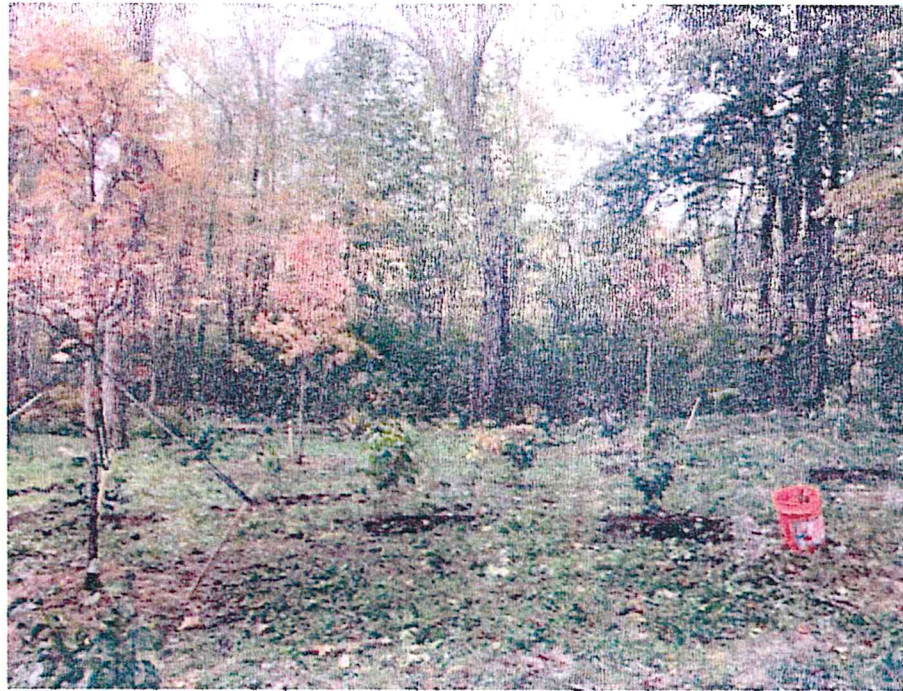
Photo 5: October, 2018

Smaller plant material was installed by hand. Larger trees were installed with the help of a mini excavator. Any disturbed soils were seeded and hay-mulched.

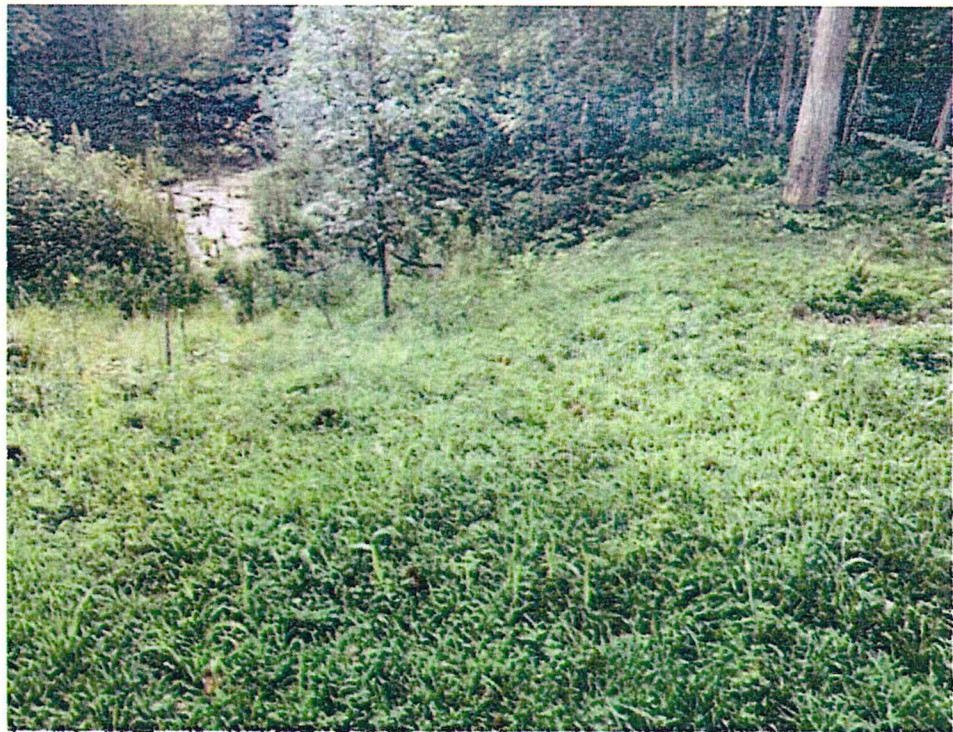
Photo 6: August, 2019

The herbaceous layer continued to establish, creating a dense ground cover. The canopy and shrub layers are also doing well.

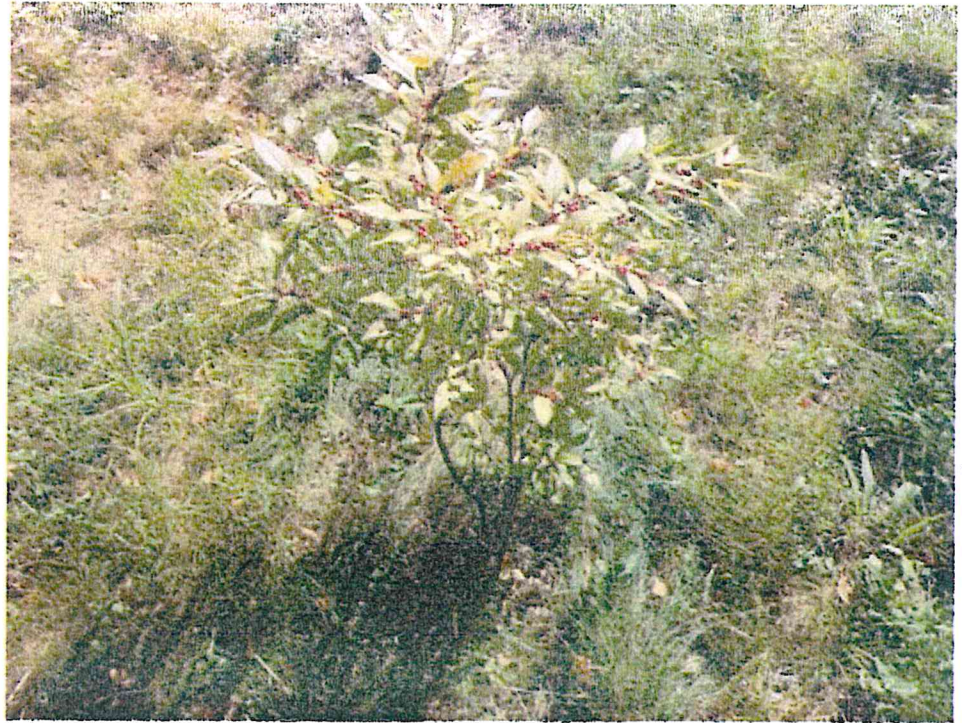
Photo 7: September, 2019

Photo taken of a healthy winterberry shrub one year after planting. The shrub is healthy with an abundance of red berries.

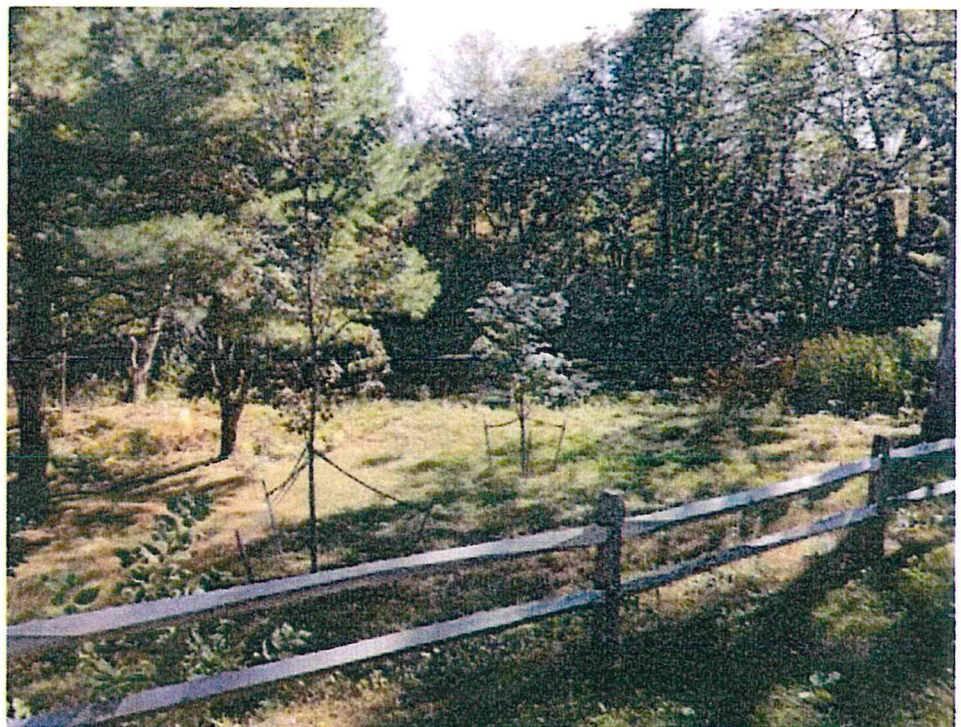
Photo 8: September, 2019

Photo of the restoration area showing a dense and established ground cover, as well as trees after one growing season.

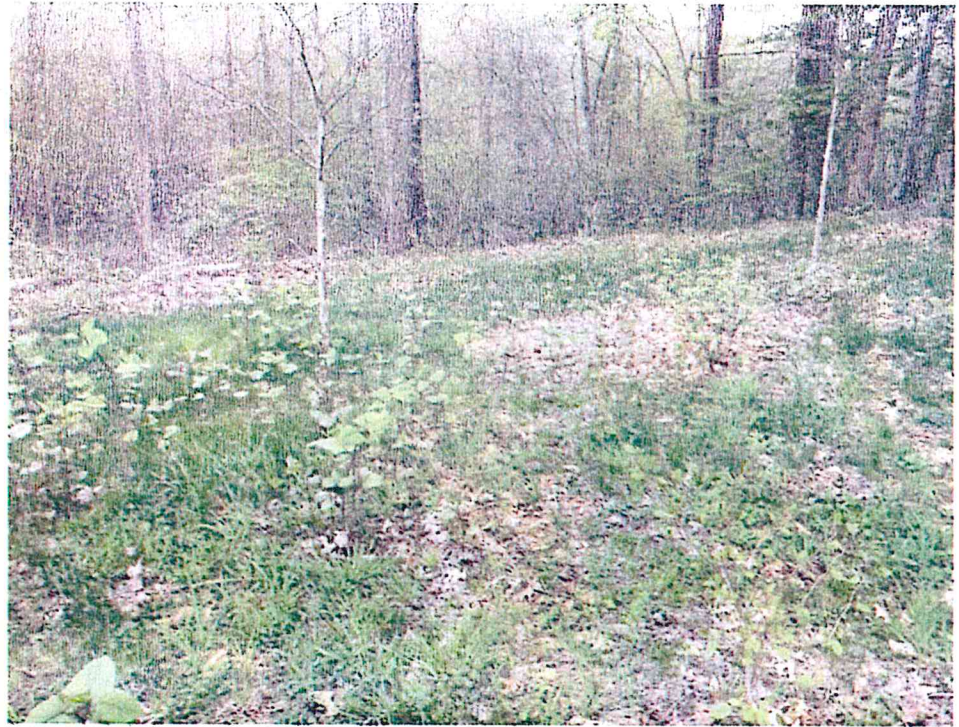
Photo 9: October, 2020

Japanese knotweed saplings continue to be removed by hand on a regular basis as part of the ongoing management plan. The invasive population has been drastically reduced since initial removal.

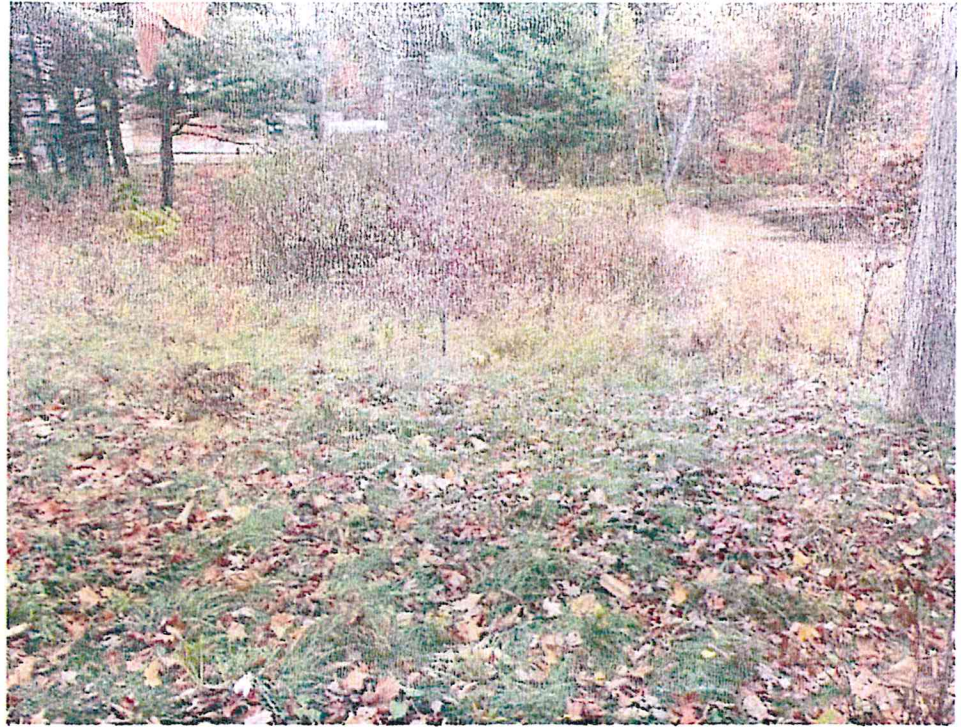
Photo 11: October, 2020

Overview of the restoration area. Native plantings are all fully established and invasive species populations have been greatly reduced.

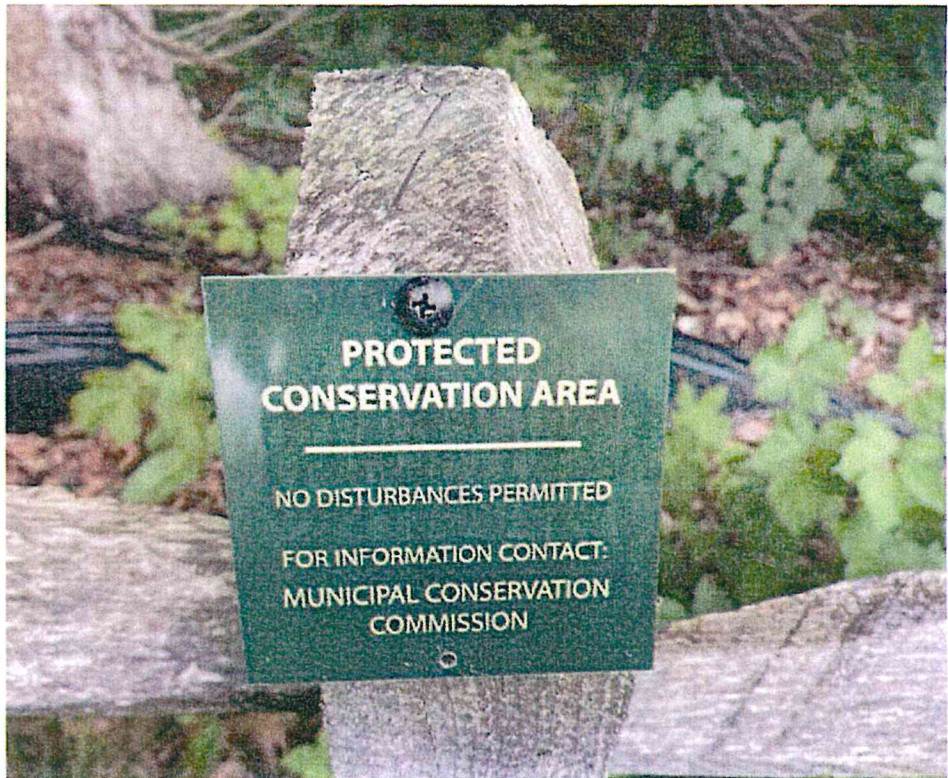
Photo 12: June, 2023

Photo of conservation markers installed on site, in compliance with the Order of Conditions.

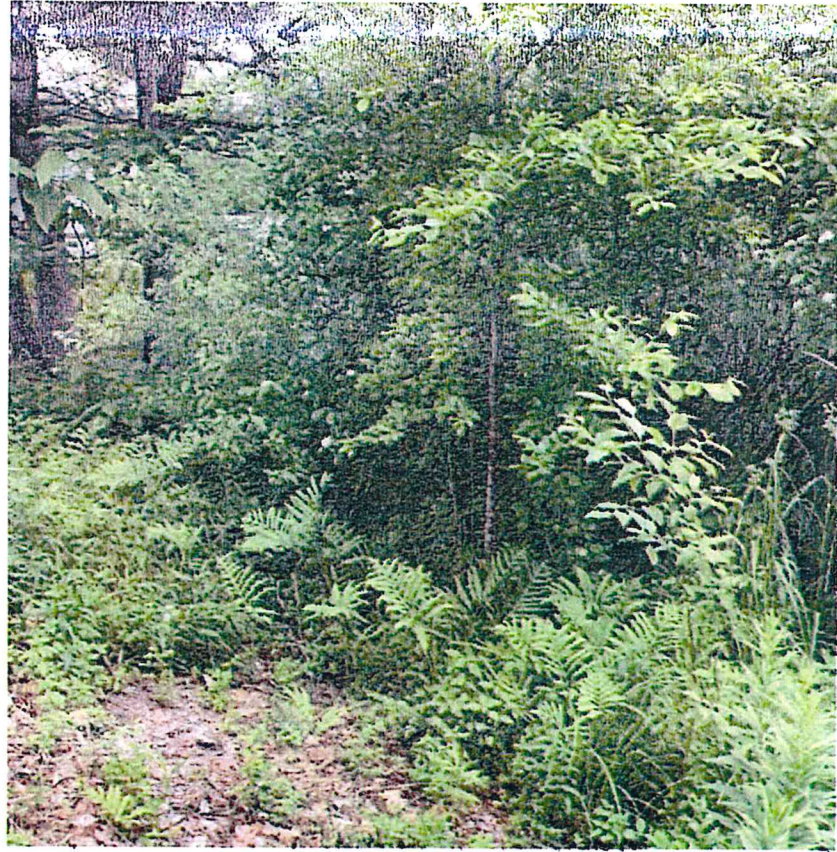
Photo 13: June, 2023

Native herbaceous species are thoroughly established across the site. Native cinnamon fern, sensitive fern, and goldenrod are visible in this photo and are thriving throughout the mitigation area.

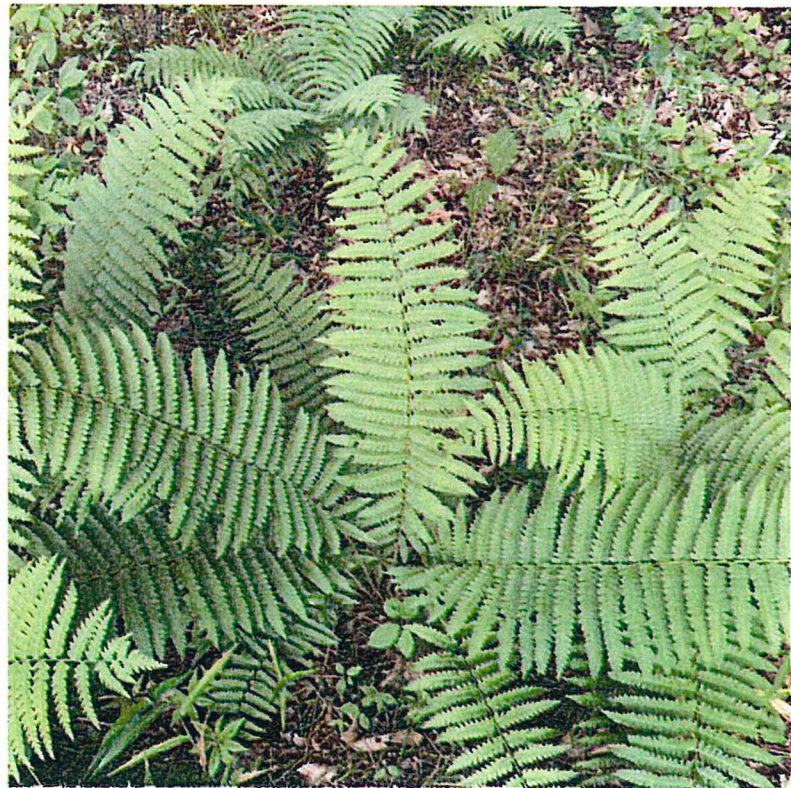
Photo 14: June, 2023

Photo of cinnamon fern. Cinnamon fern has continued to spread and propagate throughout the site since the invasive species were removed.

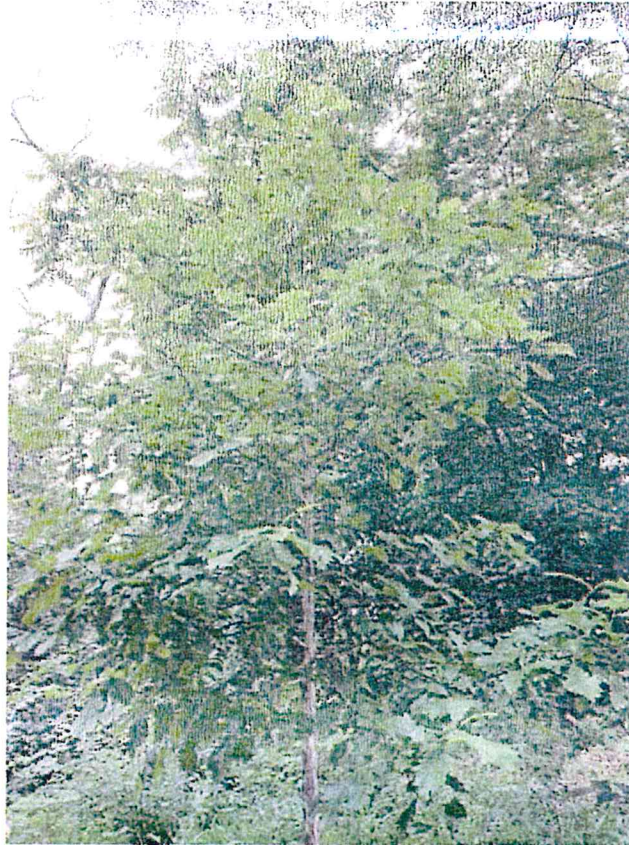
Photo 15: June, 2023

Photo of one of the white oaks planted as part of the mitigation plan. The oak has grown significantly since it was planted in 2018, is producing adequate leaves, and appears to be healthy.

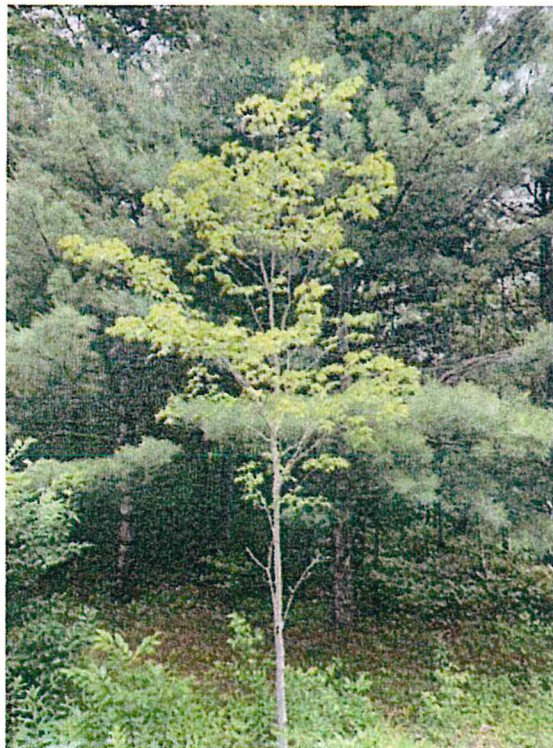
Photo 16: June, 2023

Photo of one of the red maples planted as part of the mitigation plan. The maples all appear to be healthy with adequate foliage.

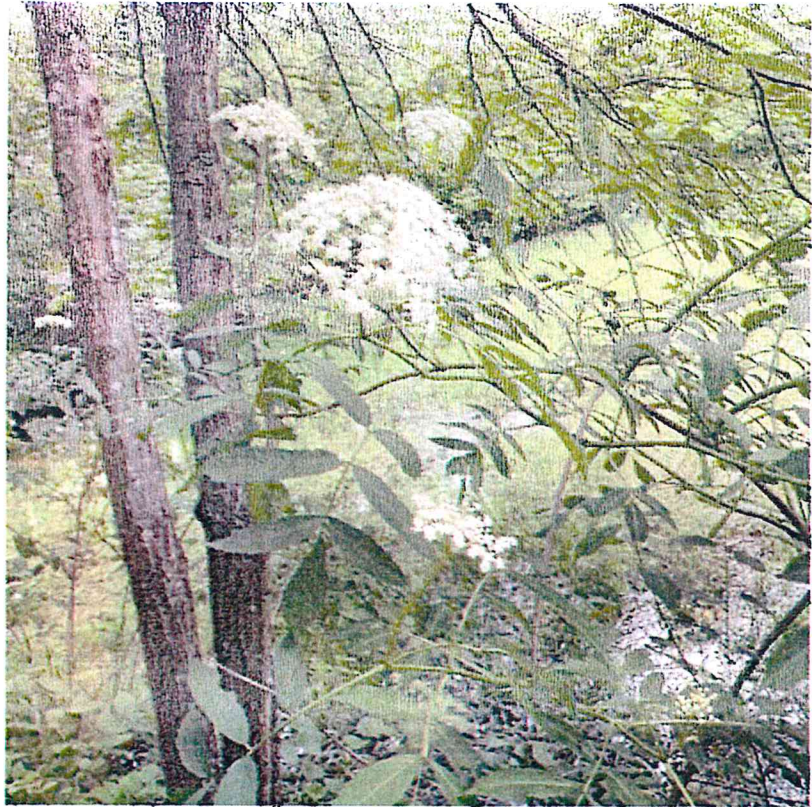
Photo 17: June, 2023

Elderberry shrubs were planted in 2018 and are well established on the site. The flowers of elderberries, pictured here, provide pollination opportunities for pollinators. The complex structure of elderberry shrubs provides important habitat for many animal species

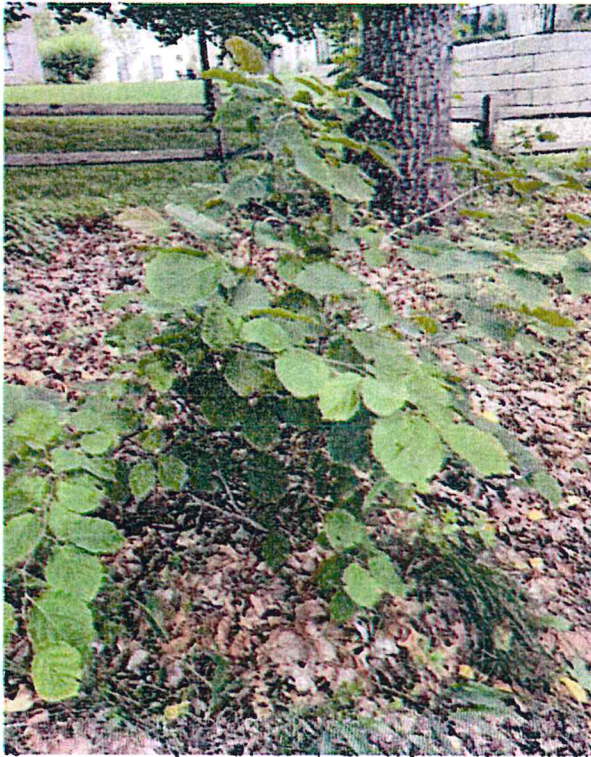
Photo 18: June, 2023

Photo of witch hazel, fully established on the site. The shrubs planted as part of the mitigation area are healthy and continue to provide improved habitat opportunities for native fauna.

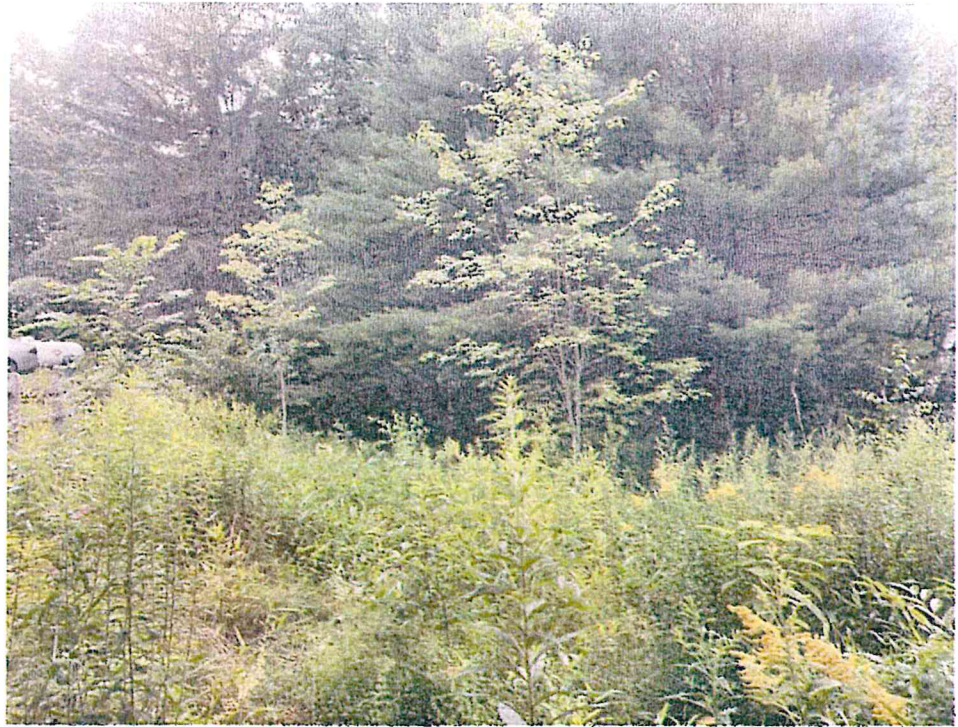
Photo 19: July, 2023

Native herbaceous species, such as Canadian goldenrod, dominate the ground cover and are outcompeting invasive species. The trees (planted in 2018), are well established and have full foliage.

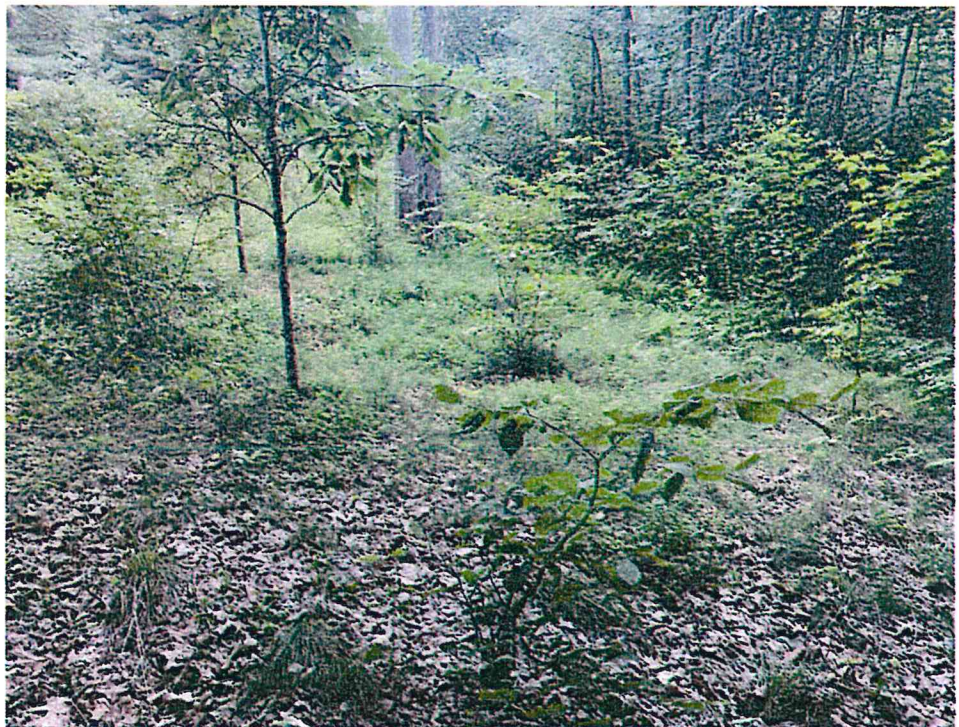
Photo 20: July, 2023

A variety of native shrubs, such as witch hazel, were planted throughout the restoration area to replace the invasive glossy buckthorn. The native shrubs are healthy, and continue to out-compete the invasive species.

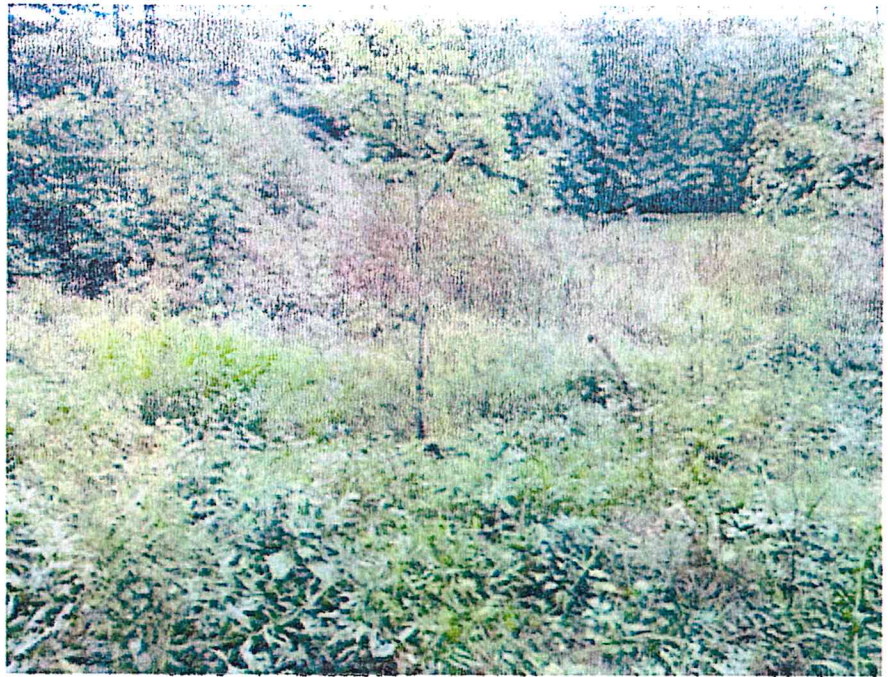
Photo 21:
September, 2023

This area was previously dominated by invasive species. Native shrubs and herbaceous plants are now thoroughly established throughout the restoration area.

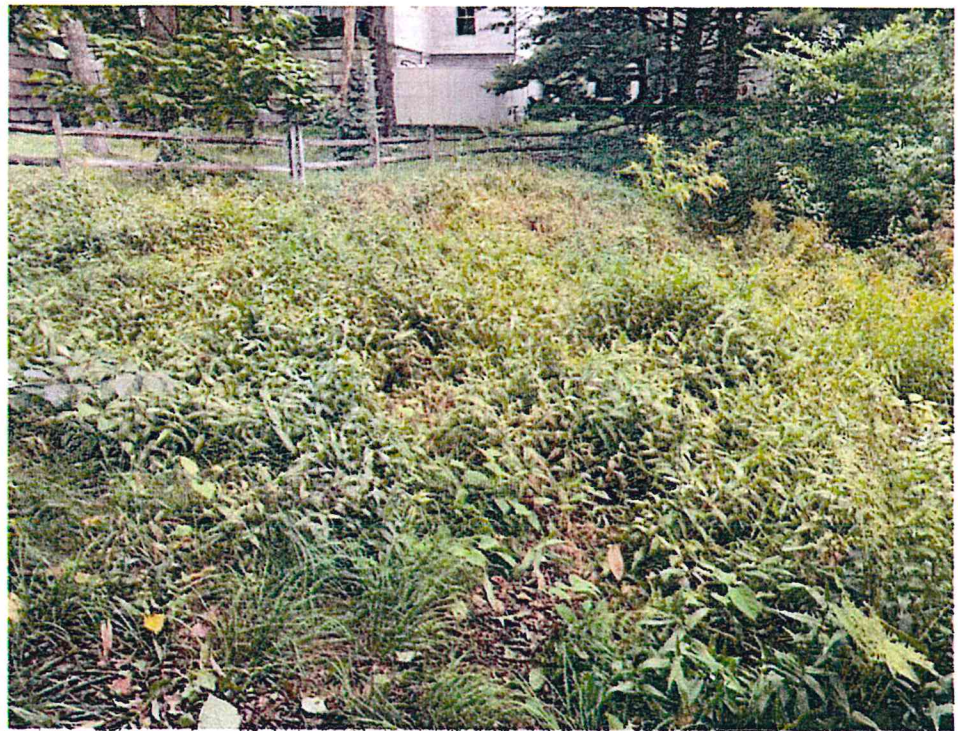
Photo 22:
September, 2023

All previously exposed soil is thoroughly stabilized with native herbaceous plants. The leaf litter visible in this photo will improve soil health as nutrients are added to the soil as the duff decomposes.

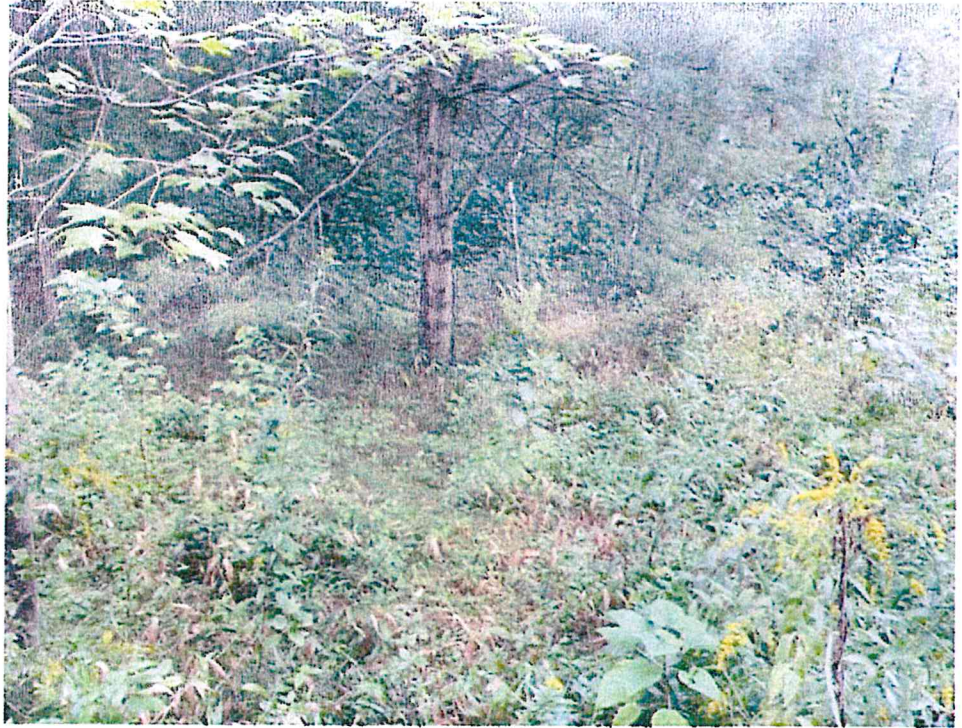
Photo 23:
September, 2023

This area, previously dominated by buckthorn and Asiatic bittersweet, now supports a diverse array of native plant species. Regular invasive species removal and management practices have allowed the desired native species to establish throughout the site, thus improving overall habitat function.

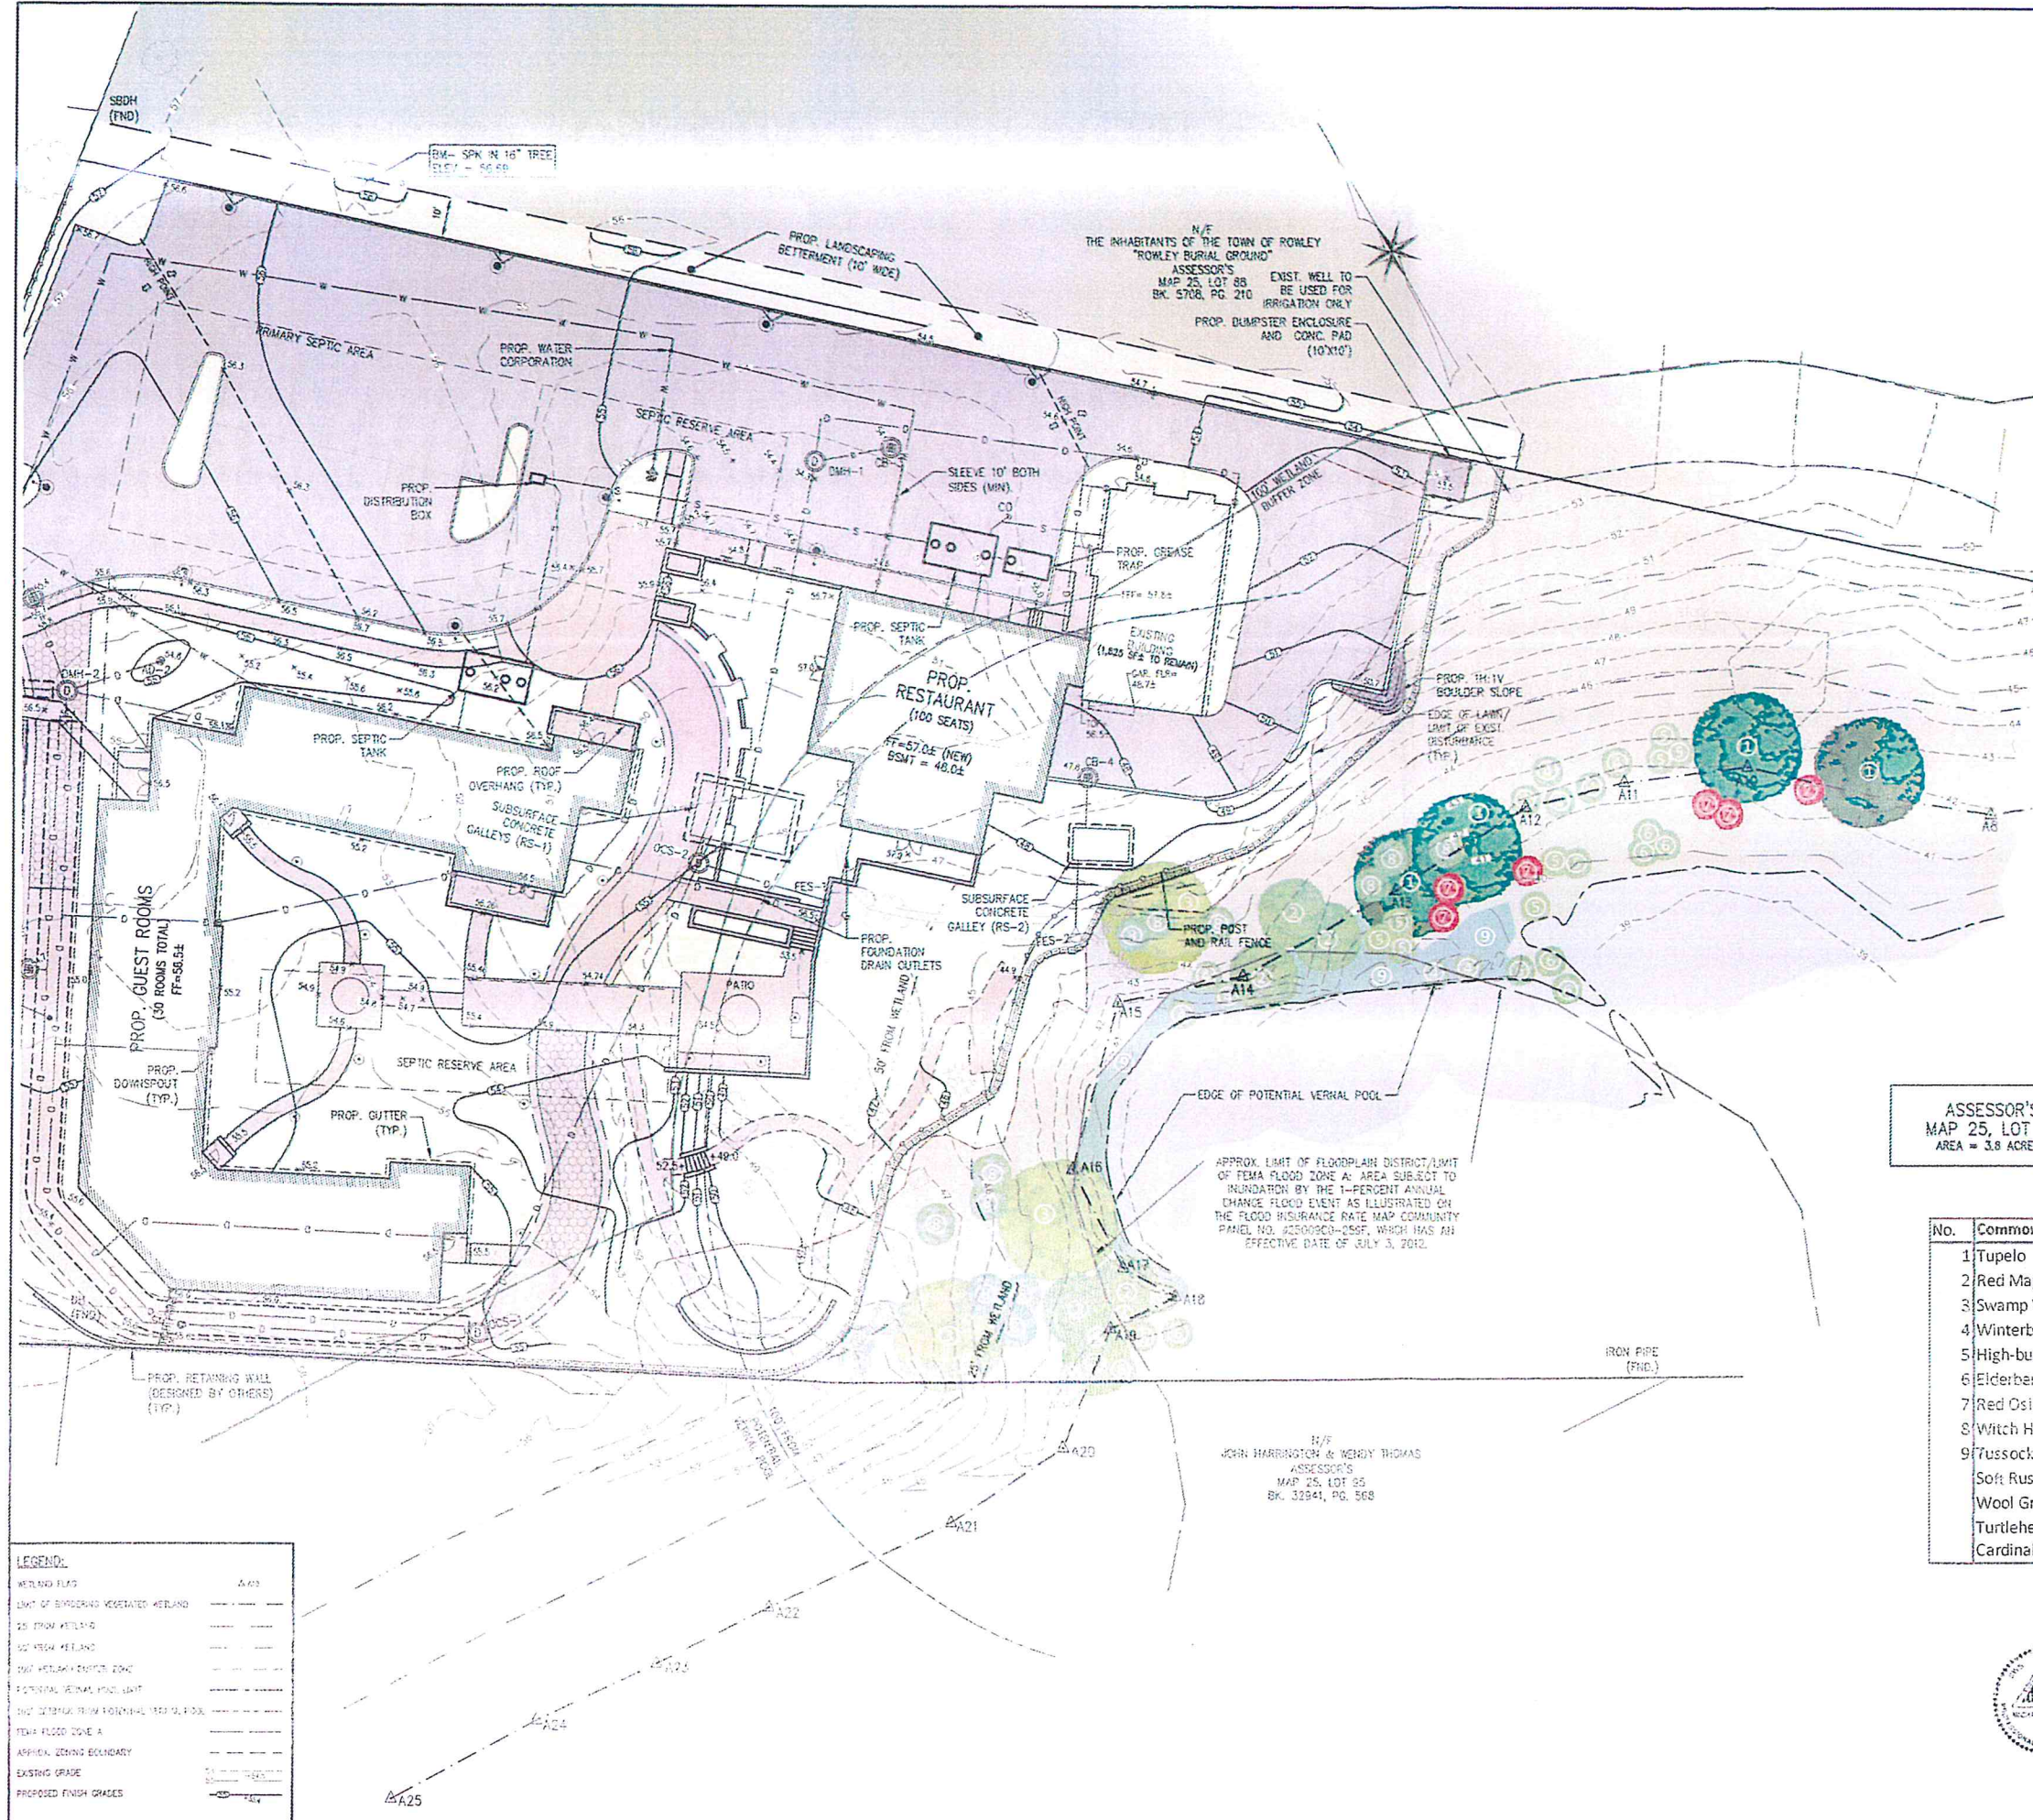
RESTORATION AND MITIGATION PLAN
DRAWING NO. **C-3**

- Notes:
1. Base Plan by the Morin-Cameron Group, Sheet C-3, dated, July 13, 2017, Project No. 3503. Planting notes added by DeRosa.
 2. Specific locations of individual plants are approximate and subject to change based on site-specific conditions at the time of planting. Plants that are not located on the plan are to be located by a restoration specialist.

3. Plant symbols do not necessarily represent individual plants. These symbols may represent massings of 3 to 5 individual plants.
 4. Soil may be augmented as needed with 1 part loam, 1 part organic compost, and 1 part sand.

5. All plant installation is to be completed by hand, except for larger specimen trees, which may require use of a mini-excavator or backhoe.
 6. Exposed upland soils will be seeded with a drought-tolerant, native grass seed mix, then hay-mulched with salt marsh hay.
